Development of Inspection Technology for NGV Fuel Tanks

Failure Analysis Associates, Inc.
Menlo Park, California

General Motors Corporation
Research & Development Center
Warren, Michigan

May 1997
(Revised August 1997)

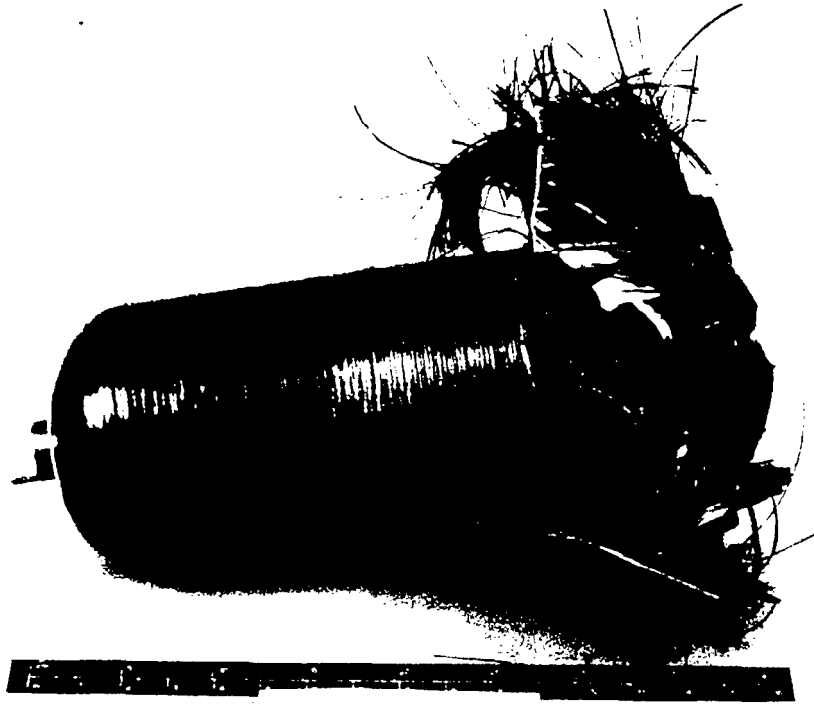
Figure 8. Burst COPV Following Impact

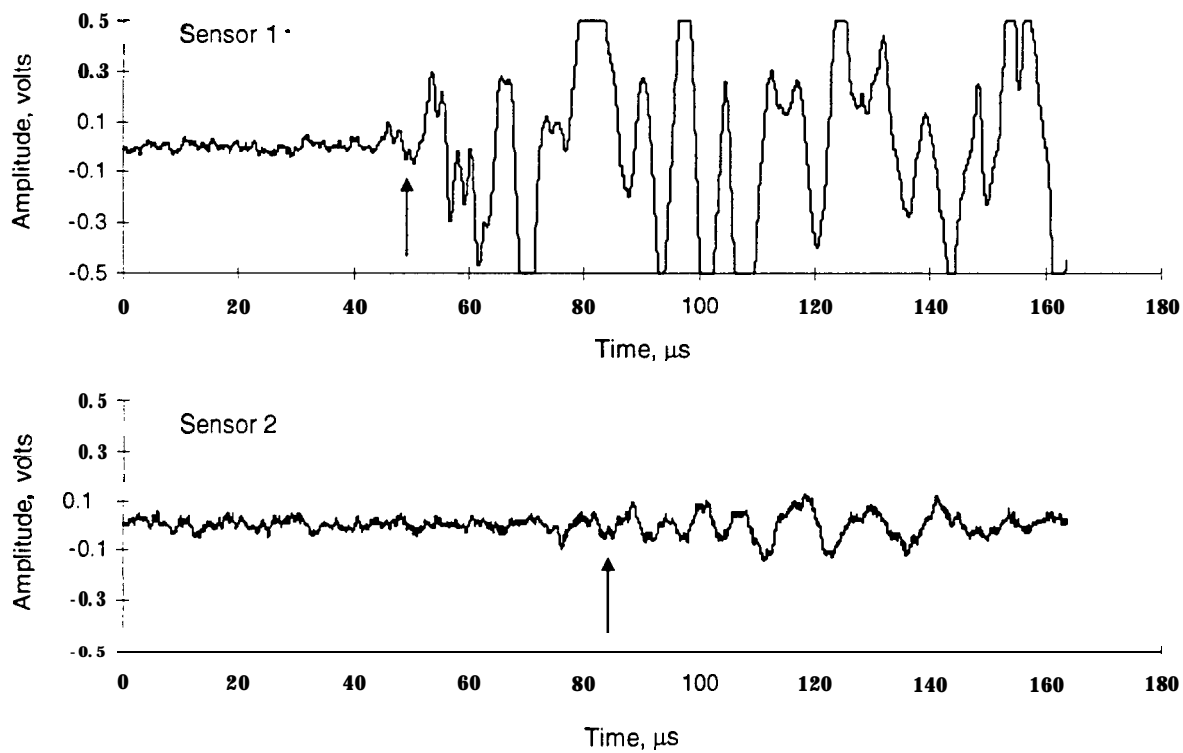
A waveform recorded during tow Test 1 is shown in Figure 22. The arrival time difference between Sensors 1 and 2 is approximately 30 μs (microseconds), indicating that the modal acoustic emission originated above the top sensor. The mode of propagation is flexural, indicating an out-of-plane source. The FFT of the waveform, Figure 23, indicates that the majority of the energy in the waveform is below 200 kHz. The arrival times, mode of propagation and frequency content all contribute to the analysis that the signal is the result of some mechanical source. This signal was identified as mechanical noise from the grips and was discarded.

Figure 22. Waveforms from One Event During Tow Test #1 – Flexural Propagation

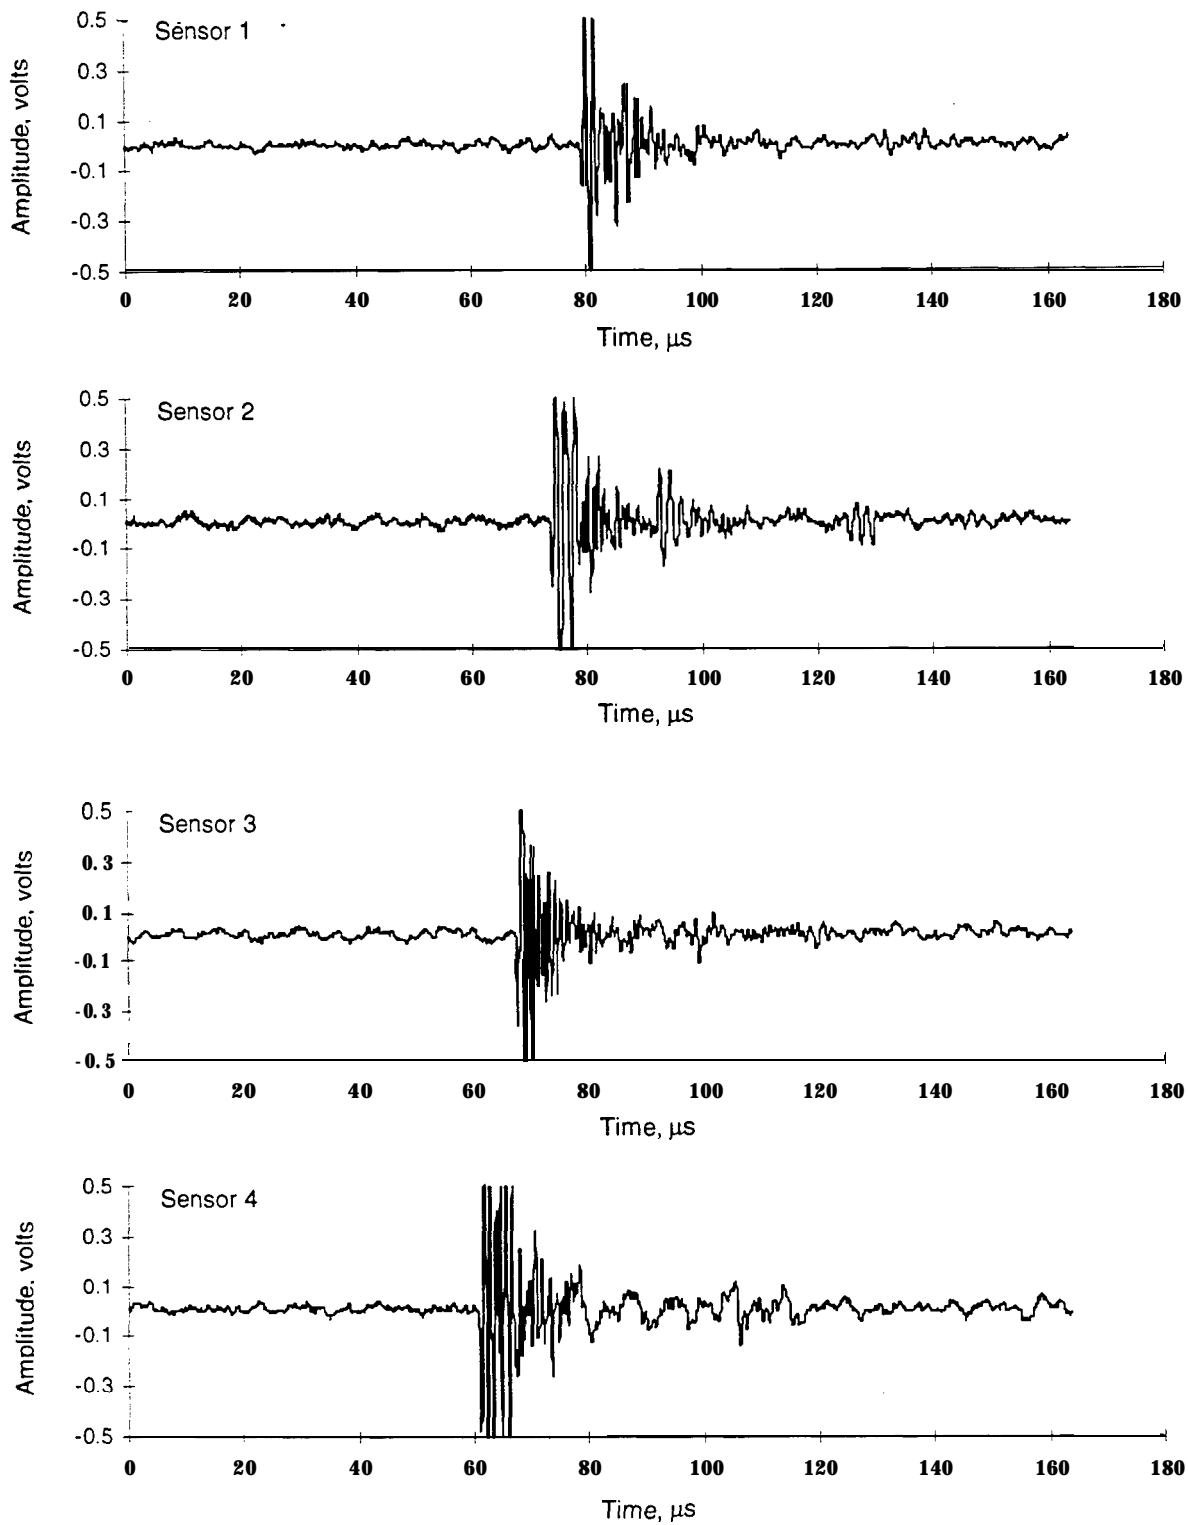
The waveform and FFT from another signal recorded during tow Test 1 are shown in Figure 24. The mode of propagation is longitudinal, indicating an in-plane source. The arrival time difference between Sensors 3 and 4 is approximately 8 μs indicating that the signal originates below the bottom sensor. The FFT, Figure 25, shows that a significant portion of the signal energy is above 500 kHz, with a peak near 1 MHz. While the arrival times indicate the source is outside the sensor array, the in-plane source and high frequency content lead to the conclusion the signal is either the result of a fiber bundle break or matrix crack.

Figure 24. Waveforms from One Event Durino Tow Test #1 – Extensional Propagation

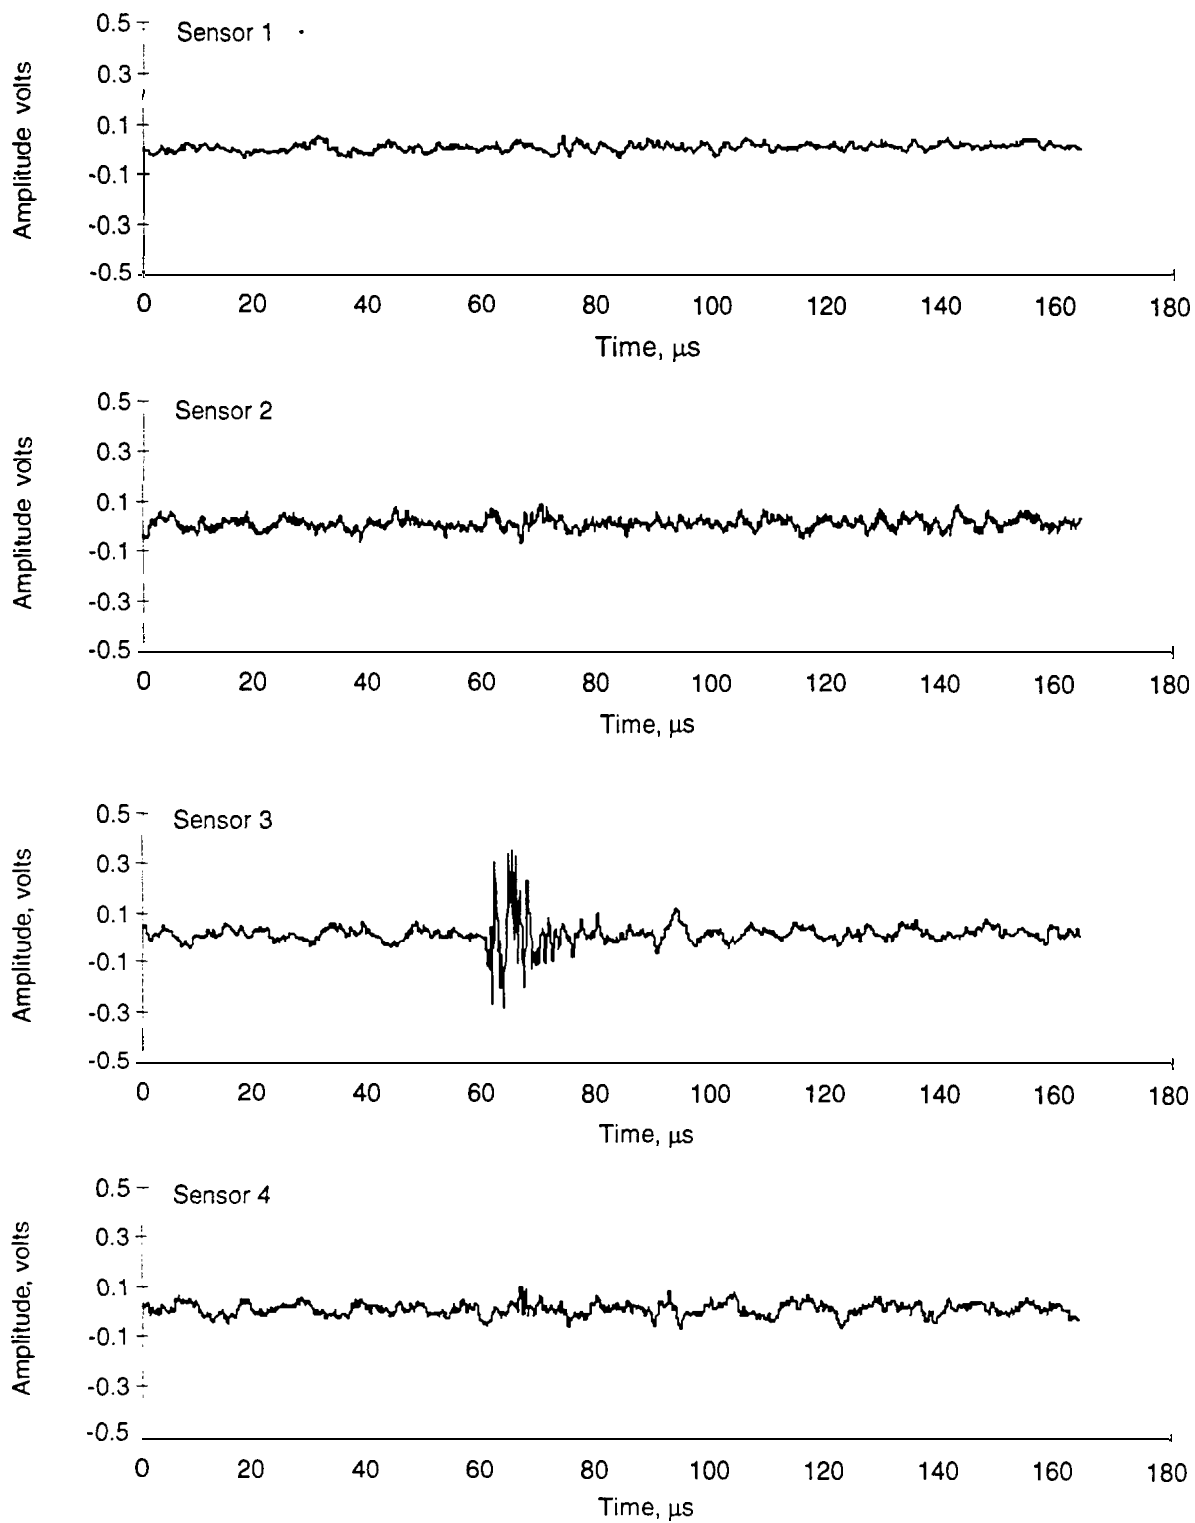
Aside from noise, three typical acoustic emission event types were identified during the tow testing. The first type, shown in Figure 26, was an event that was recorded with significant amplitude on a single channel only. The waveform has a short duration and a significant percentage of the energy is in high frequency components. The single channel events are small amplitude events that occur near the individual sensors. The waveform is most likely attenuated before traveling to the other sensors. These small amplitude events may be due to sources, such as matrix cracking, single fiber breaks, and fiber debonds. Determination of the source mechanism for the small amplitude events would require visual verification using microscopic examination, which was beyond the scope of this study.

Figure 26. Typical Single Channel Event Recorded During Testing

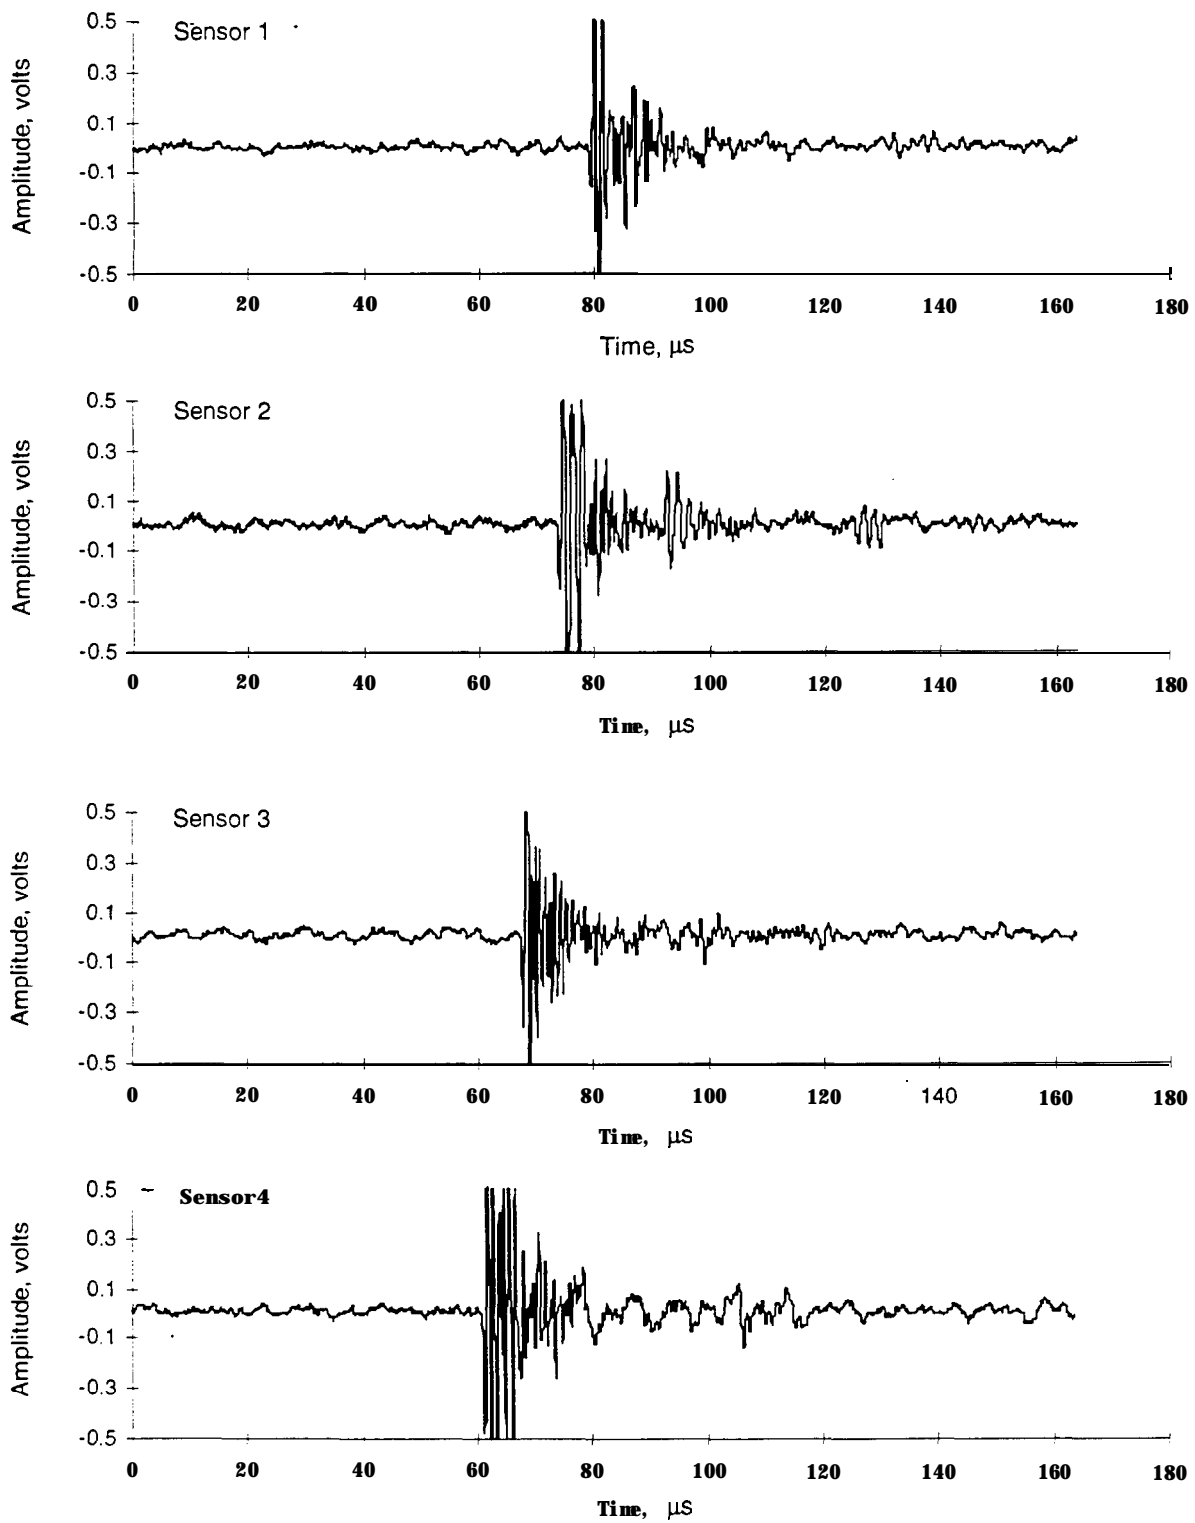
The second typical signal was a high frequency, short duration pulse recorded on all four channels, shown in Figure 27. These waveforms have a short duration, significant high frequency content, and are propagating in the longitudinal mode. The high amplitude of the signal indicates that the source released a significant amount of energy.

Figure 27. Typical High Frequency, Short Duration Event

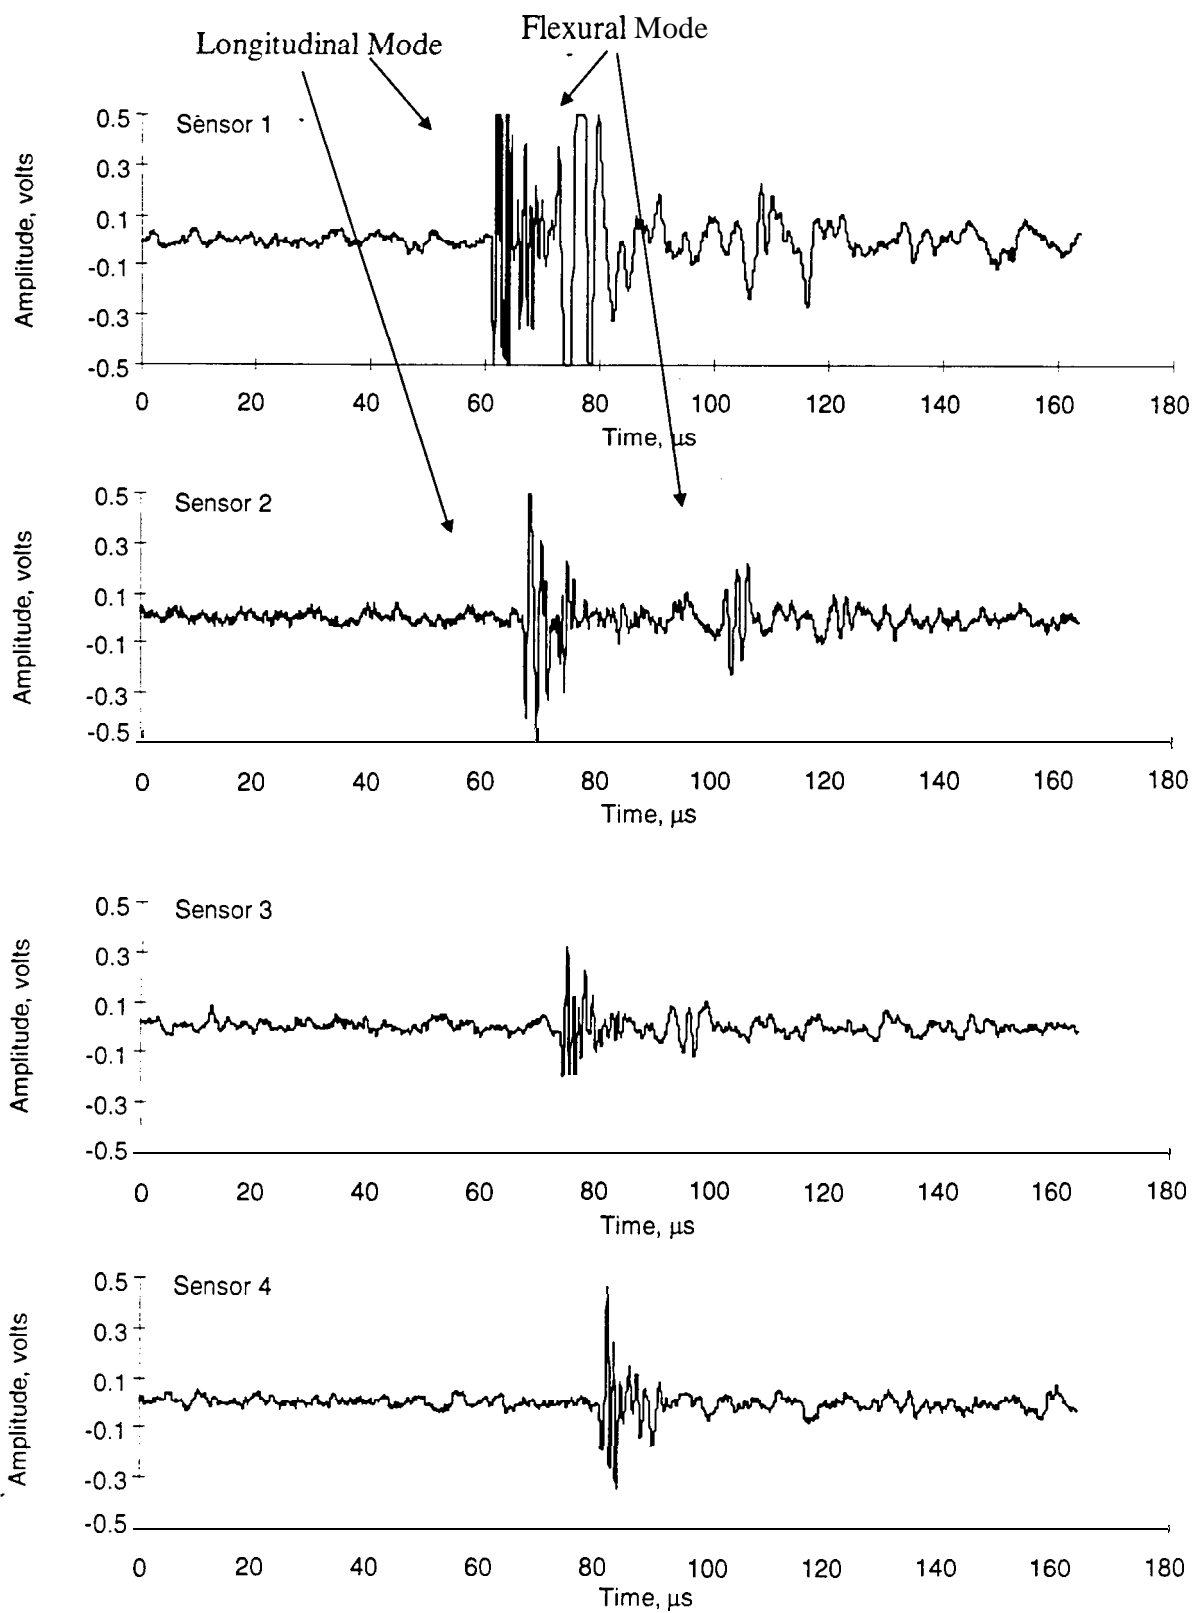
The third signal was similar to the second, except for a large trailing flexural mode in the waveform. An example of this type of signal is presented in Figure 28, which shows a fiber break signal with a flexural mode component. The large low frequency portion (near 70 μ s) of the wave form in Channel 1 is a flexural mode. The flexural mode is still visible in Channel 2, near 100 μ s, but it has been attenuated. Also, the difference in velocity between the longitudinal mode and flexural mode is clearly seen in the arrival time differences between Channels 1 and 2.

Figure 28. Fiber Break Signal with Flexural Component

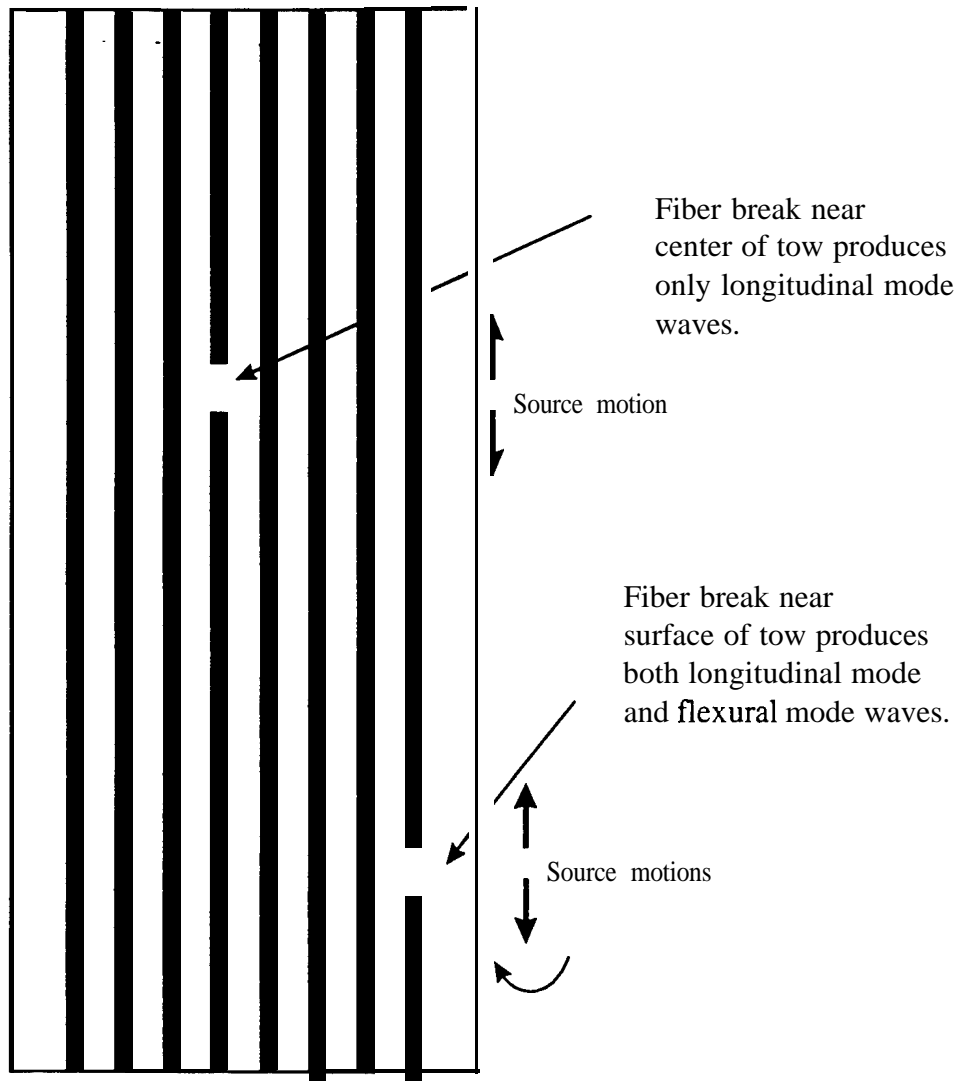
These different events have several possible source mechanisms. The second and third signal types can possibly be explained by single fiber breaks or fiber bundle breaks. A fiber/bundle break near the center of the tow is essentially an in-plane source and should produce only longitudinal mode vibrations. A fiber/bundle break near the surface of the tow will produce a longitudinal wave from the fiber separation, as well as a flexural mode from the moment generated by the off-axis stress redistribution. The different possible source locations are illustrated in Figure 29.

Figure 29. Schematic of Possible Fiber Break Locations in the Tow Test Specimen

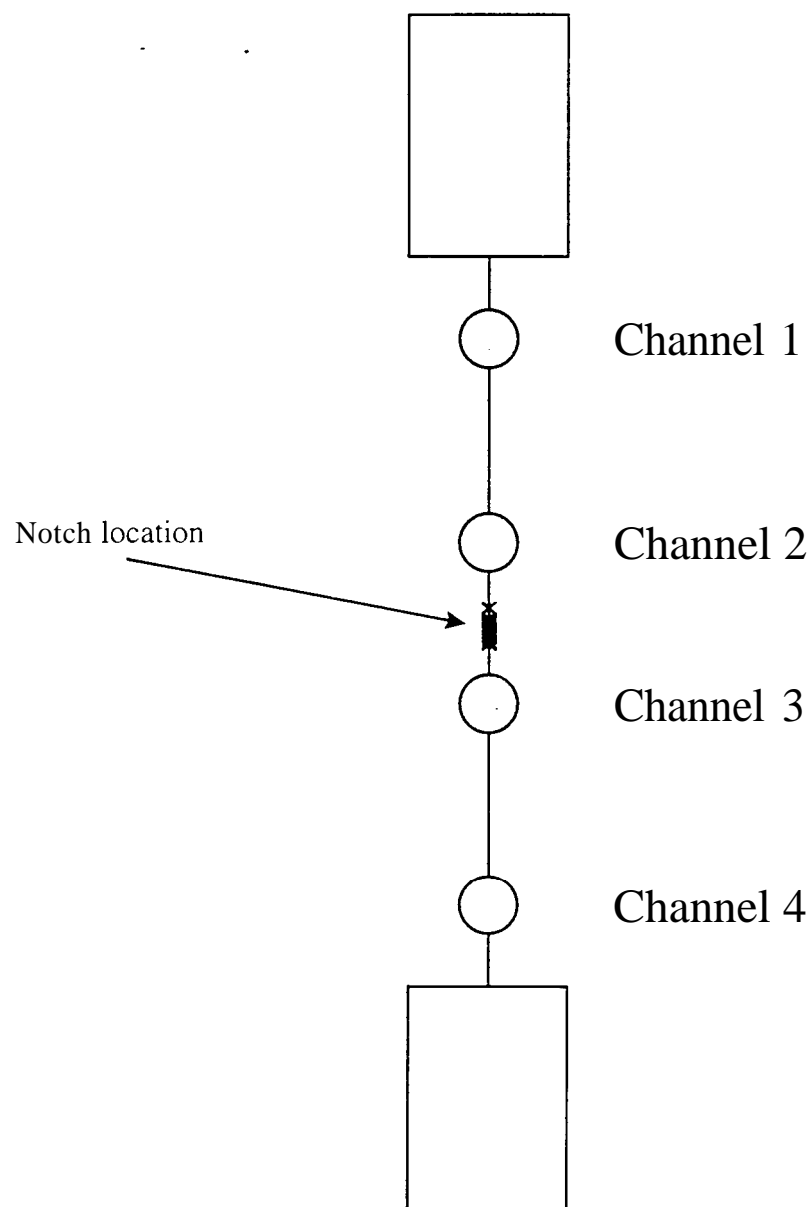
Waveform arrival times can be used to calculate the location of the acoustic emission source. The small notch cut into tow test Specimen 4 produced a stress concentration near the notch. The fibers in the tow should fail near the notched area first. Using sensor locations and large amplitude waveforms recorded before the crack splitting, source locations were calculated. The relative arrival times at each sensor were calculated from the first peak of the nondispersive longitudinal mode. A typical waveform used for source location is shown in Figure 30. Source locations are then calculated using the velocity of the longitudinal mode (10,000 m/s), the arrival times, and sensor locations. A plot of the calculated source locations for Specimen 4 is shown in Figure 31. Figure 31 also shows that the sources are in the vicinity of the notch. As predicted, the fibers failed in the area near the notch.

Figure 3 1. Calculated Source Locations for Tow Test Specimen 4

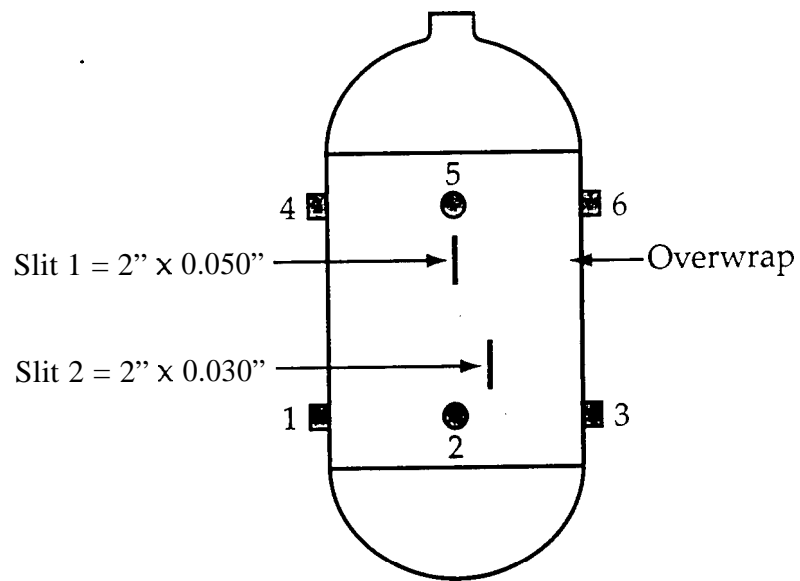
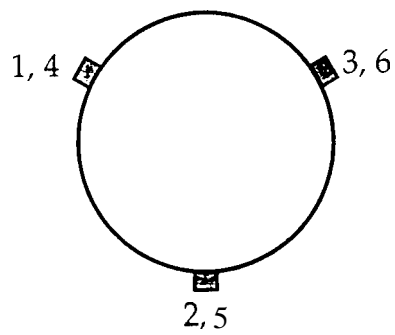
Figure 33. Configuration of Tank 004 Sensors and Damage

Two longitudinal slits were then machined in the overwrap of Tank 004 as a means of introducing defects into the overwrap (Table 5). The locations of the slits are shown schematically in Figure 33. One slit, 2 inches long x 0.050 inches deep, was located near one end of the over-wrap and the other slit, 2 inches long x 0.030 inches deep, was located near the opposite end of the over-wrap. The two slits were offset by approximately 2 inches in the circumferential direction. These slits are twice as long as the 1 inch long longitudinal flaws specified in ANSI/NGV2. Acoustic emission of damaged Tank 004 was measured during hydraulic pressurization and pressure cycling. Five pressure cycles were applied to maximum pressures of 3,600 psig, 4,500 psig, and 4,800 psig.

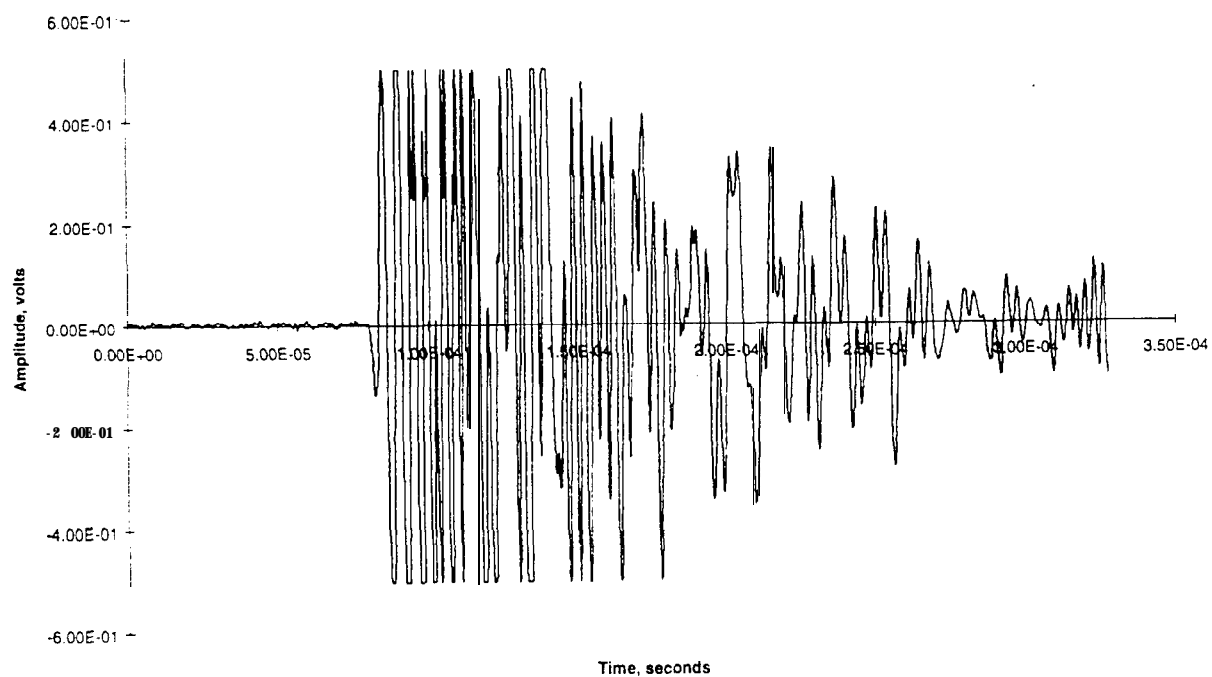
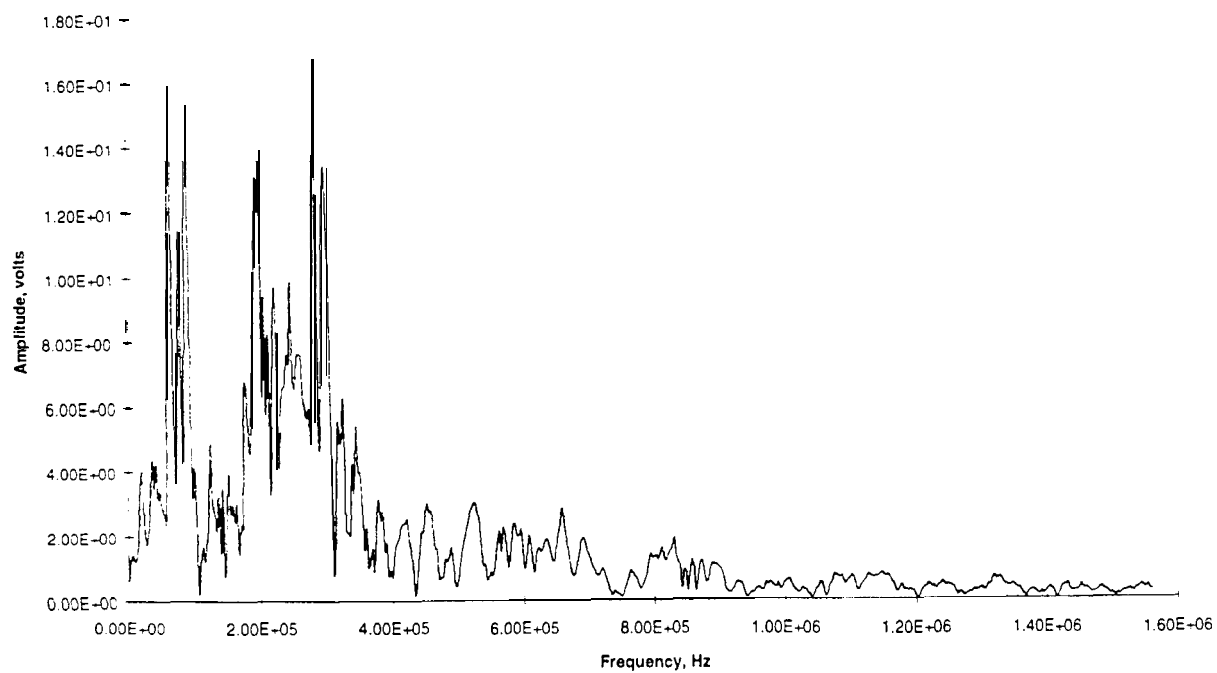
Figure 36. Matrix Splitting Signal and FFT of Signal – Tank 004 with Slits

The observed cracking and delamination from the slits was reflected in the acoustic emission data, which was attributed primarily to matrix cracking rather than fiber breakage. Large amplitude flexural mode signals, Figure 36, were seen to be originating from the slits. As the

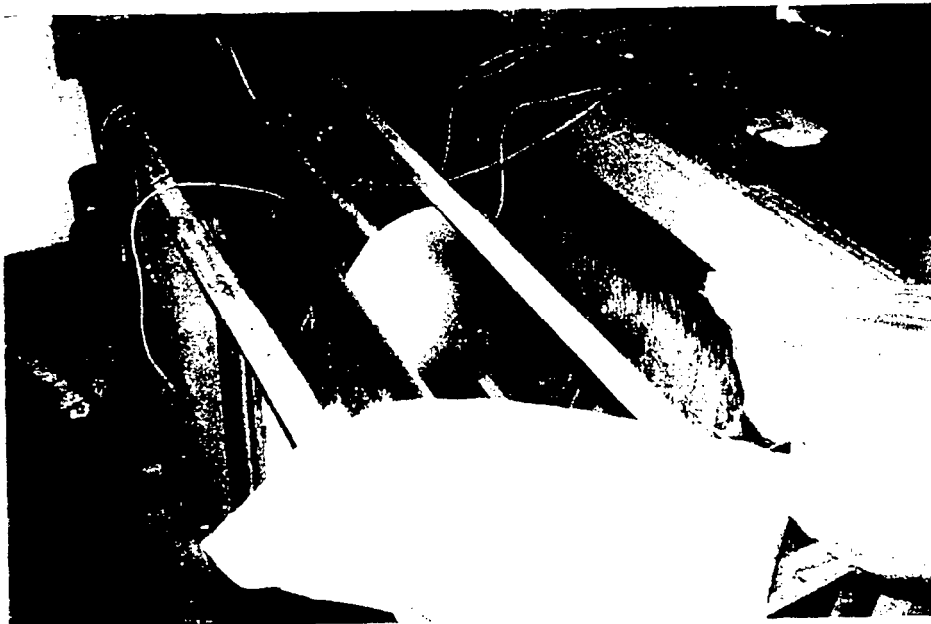
Figure 48. Pendulum Impact Fixture in Burst Test Chamber

The pendulum impact fixture was designed to impact the tank while it was in the burst test chamber, as shown in Figure 48. A close-up view of the pyramid-shaped impactor is shown in Figure 49. The impact site following the 22.1 ft-lbs impact is shown in Figure 50. Several hoop cracks and two shallow dents were created by the impact. The visual extent of the damage, indicated by the rectangular region in Figure 51, is approximately 1.5 inches circumferentially x 0.5 inches axially. Pressurization of the tank to 5504 psig produced audible noise and significant acoustic emission. Following pressurization, the fibers in the damaged area were lifted from the surface, but no apparent crack growth was observed.

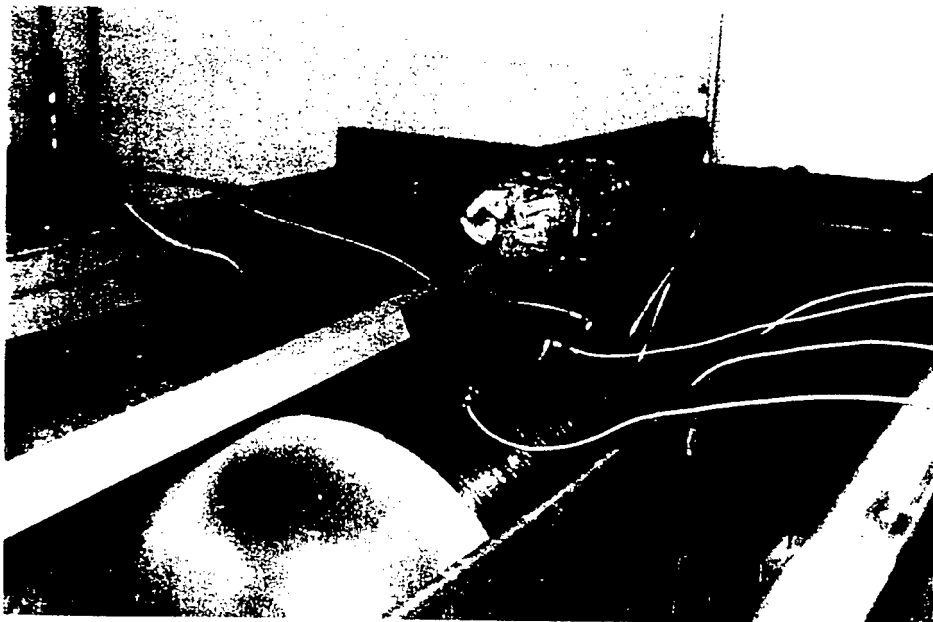
Figure 52. Pendulum Impact Fixture for 221 ft-lbs Impact

Weight was added to the pendulum impact fixture in order to increase the impact energy to 221 ft-lbs, as shown in Figure 52. The tank was also rotated so that the impact occurred at approximately the same longitudinal location but at a circumferential location approximately the same distance from Sensor 2 as the 22.1 ft-lbs impact. The appearance of the 221 ft-lbs impact damage, which includes circumferential cracks, fibers lifted off the surface, a 0.125 inch deep dent, and a shallow dent, is shown in Figure 53. The size of the visibly damaged area is approximately 2.25 inches circumferentially x 0.5 inches axially. No change in the damage was observed following pressurization of the tank to 5529 psig.

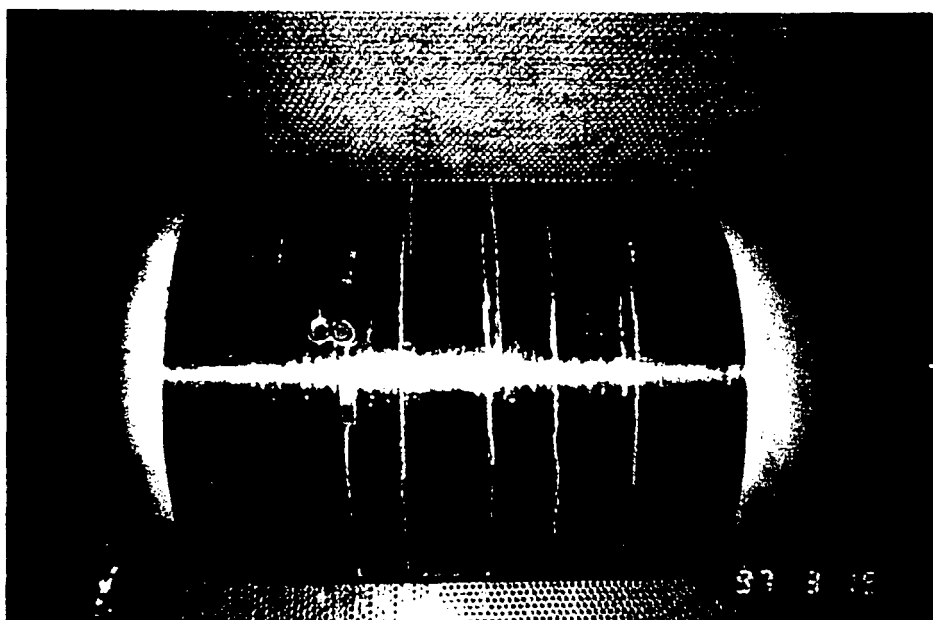
Figure 54. Tank 013 in the Fatigue Test Chamber, 0" View

illustrate the circumferential crack growth. In Figure 54, the 2 inch long slit is visible in the upper right above Sensor 5, with yellow lines indicating the circumferential cracks emanating from each end of the slit. The pair of yellow lines in the center of the tank are associated with cracks from the 3 inch long slit, which is seen in the upper center of Figure 55 between Sensors 3 and 6. Due to fatigue cycling, the ends of the two slits separated and the slits delaminated from the underlying over-wrap. The two impact damaged areas and their associated cracks are shown in the left of Figure 54 near Sensors 2 and 7. Notice that the crack propagates between the two damage areas and continues around the circumference of the tank.

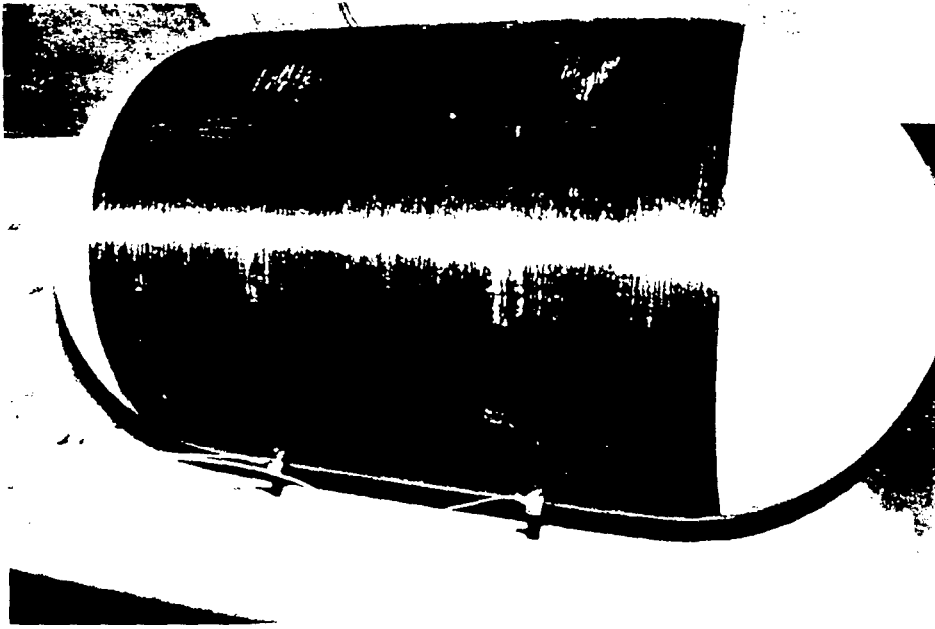
Figure 57. Acoustic Emission Sensors on Tank 0 14

Tests and results for Tank 014 are summarized in Table 9. The as-received Tank 014 is shown in the burst test chamber in Figure 56. In Figure 57, notice the circumferential cracks in Tank 014, which are presumed to be associated with the autofrettage pressurization. The white areas on the top of the tank are typical scuff-type damage observed on the as-received tanks. The four acoustic emission sensor locations are shown in Figure 57. For practical reasons of schedule and convenience, four sensors, rather than seven, were used on Tank 014. The sensors were located at the same axial locations as on the other Type 2 tanks, but the sensors were located 180° rather than 120° apart. Previous testing of Tank 013 indicated that four sensors was the minimum required to cover the overwrap.

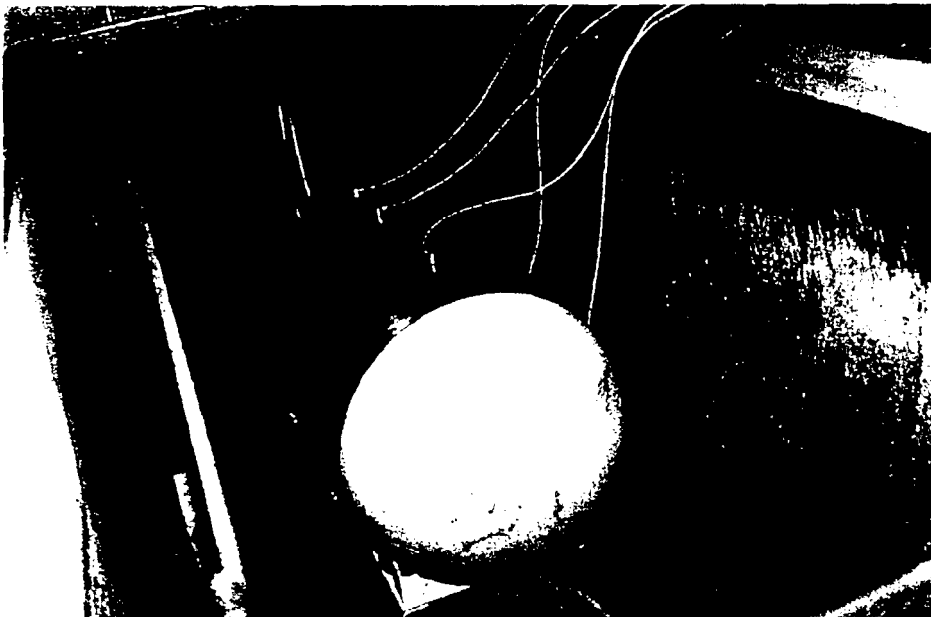
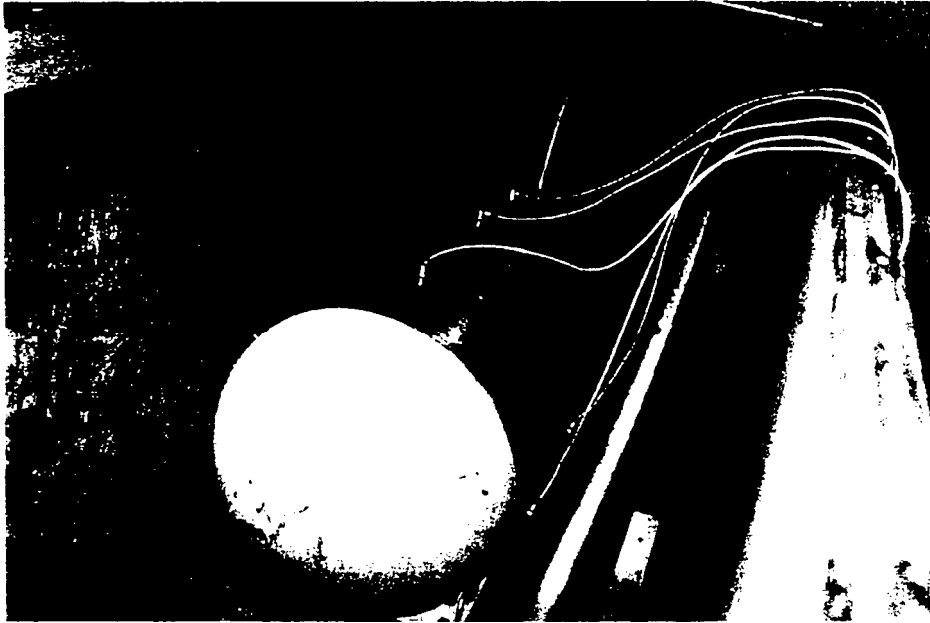
Table 10 summarizes the testing and results for Tank 018. The as-received Tank 018 is shown in the burst test chamber in Figures 58 and 59. The seven acoustic emission sensor locations are visible in these figures. These are the same locations used on Tank 013. Pressurization of the as-received Tank 018 produced significant acoustic emission at 7,200 psig, just above the autofrettage pressure of 7,100 psig.

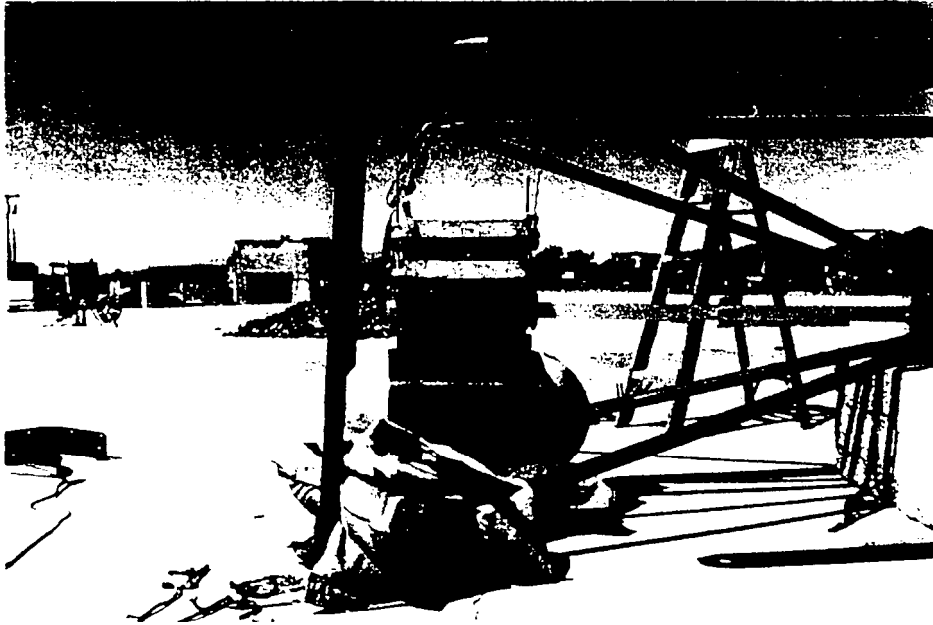
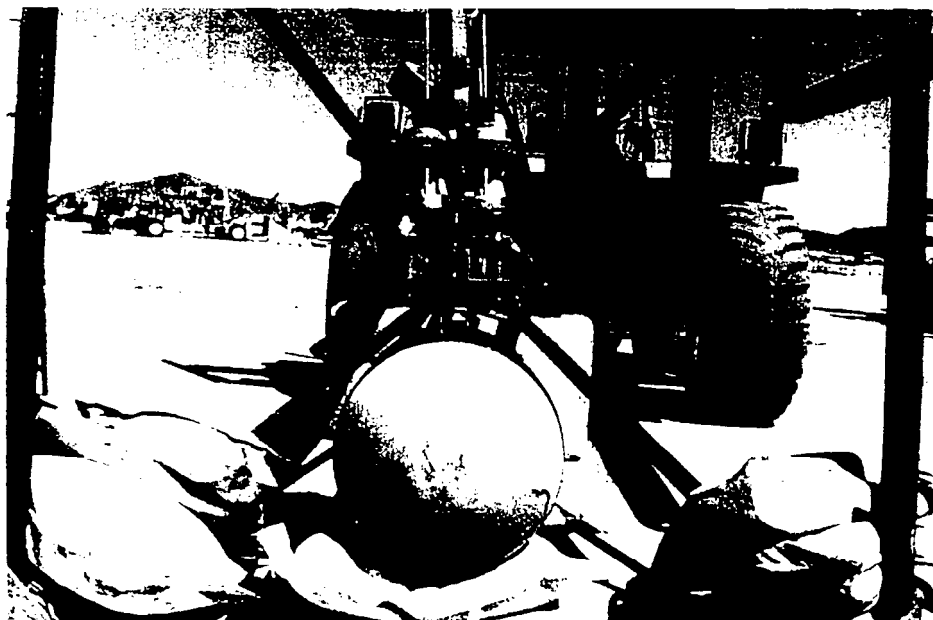
The test set-up for impacting Tank 018 in the large impact test facility at an impact energy of 2,050 ft-lbs is shown in Figures 60 and 61. As shown in the figures, the impactor is a steel box-section 2 inches wide x 17 inches long, so that the impactor contacted the tank along the entire length of the over-wrap over a 2 inch circumferential length. The test facility just prior to release of the pendulum is shown in Figure 62. Views of the post-impact damage are shown in Figures 63 and 64. The damage appears as a series of light circumferential lines approximately equally spaced along the length of the overwrap. The circumferential extent of the damage is greater toward the closed end of the tank. The post-impact Tank 018 was pressurized to 7,200 psig and exhibited no significant difference in acoustic emission response from the as-received tank, indicating no significant effect of the impact on the over-wrap.

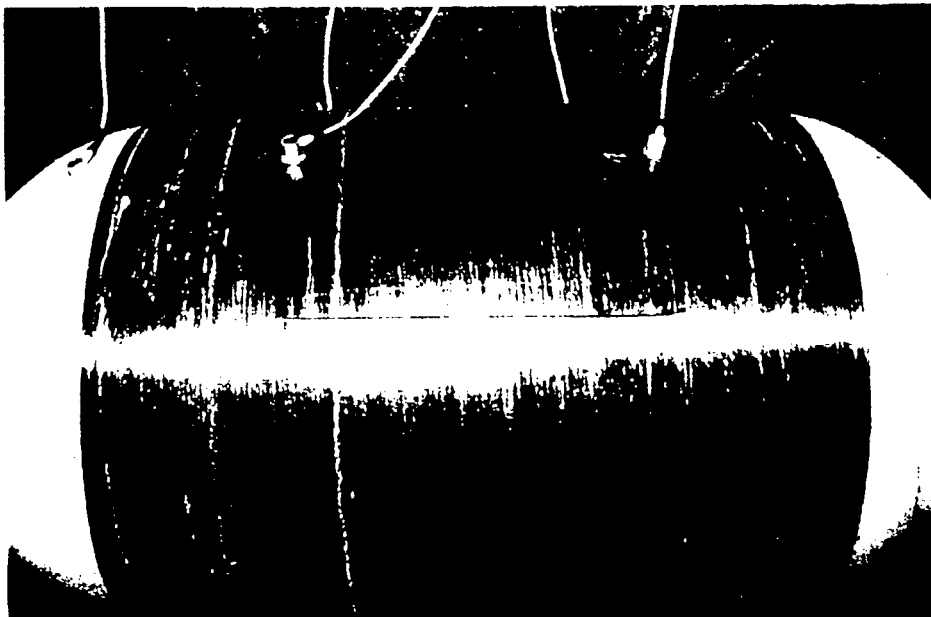
Figure 65. 8-inch Slit Cut in Tank 018

The 8 inch long x 0.18 inch deep slit in the over-wrap of Tank 018 is shown in Figure 65. The tank was pressurized to 4,530 psig, which produced significant acoustic emission. Following one pressure cycle, the ends of the slit separate, as shown in Figure 66, and circumferential cracks propagate from the ends of the slit, as shown by the yellow lines in Figure 67. Prior to fatigue testing, a few remaining fibers were cut so that the slit penetrated through the entire thickness of the overwrap, as shown in Figure 68. After 3,000 pressure cycles in the fatigue chamber, the ends of the slit separate further, as shown in Figures 69 and 70. Views of the tank after 15,000 cycles, shown in Figures 71 and 72, show that the ends of the slit are separated by approximately the same distance as after 3,000 cycles. Cracks emanating from the ends of the slit propagated all the way around the circumference of the tank, indicated by the yellow lines in Figure 71. Also, the entire band of the overwrap was observed to be delaminated from the liner.

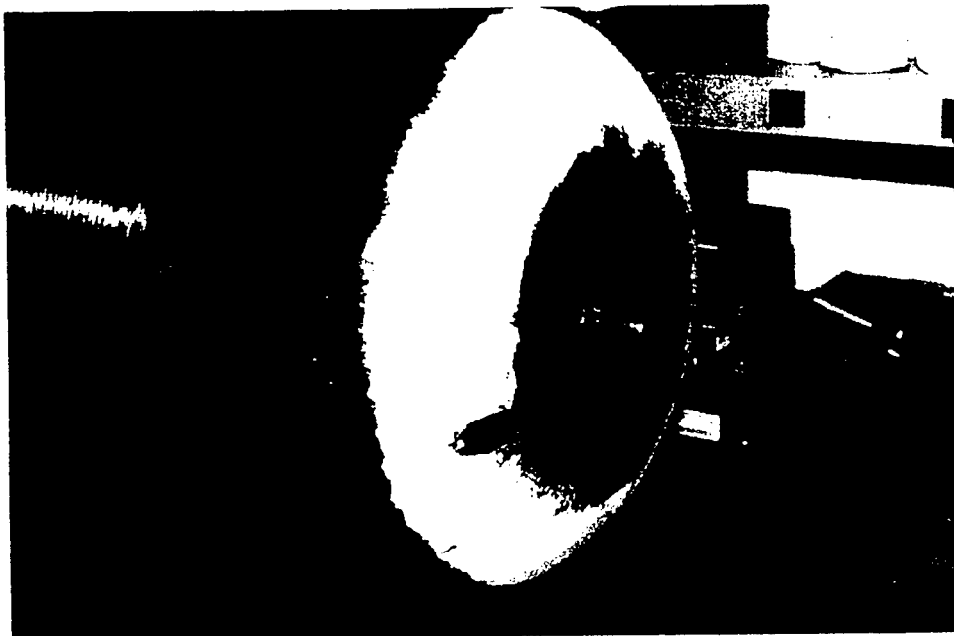
Figure 74. Tank 003 with Rubber Bumper Removed; White Material is Styrofoam

Results and testing for Tank 003 are shown in Table 11. Tank 003, a Type 4 tank fabricated by Edo, is shown in Figure 73. The external rubber bumpers on the shoulders of the tank were removed for this test. The white area in Figure 74 corresponds to the prior location of the bumper, which is shown following removal in Figure 75. The white material is the Styrofoam underneath the bumper, which was removed prior to testing, as shown in Figure 76. Tank 003 is shown in the burst test chamber for characterization of the as-received tank in Figure 77. Six of the seven acoustic emission sensor locations are also visible in Figure 77. Four of the sensors (Sensors 1-4) were positioned 180° apart at two axial locations, 3 inches from the closed end of the over-wrap and 11.5 inches from the open end of the overwrap. The other three sensors (Sensors 5, 6, and 8) were positioned on either side of the impact site along an external fiber direction. Pressurization of the as-received Tank 003 to 6,062 psig produced significant acoustic emission.
